Fractography analysis of tool samples used for cold forging

Abstract Three fractured tool dies used for industrial cold forging have been investigated using light optical microscopy and scanning electron microscopy. Two of the specimens were produced using the traditional Böhler P/M steel grade s790, while the last specimen was a third generation P/M steel produced using new technology developed by Böhler. All three steels have the same nominal composition of alloying elements.

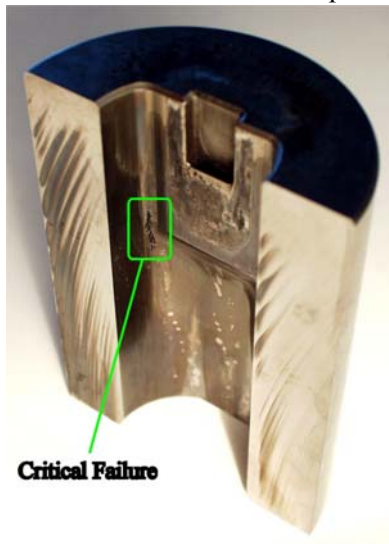
Figure 3-1 Tool sample with visible crack.

The tool samples, which have been used as a die for cold forging of a yoke, have an outer diameter of 63 mm. On Figure 3-1 one of the test samples is shown. The sample has been cut in half in order to reveal the place of failure.

As can be seen from the picture, the crack is located at an inner notch in the specimen, which is the location with the highest stress intensity (see Figure 3-2). The crack runs along the entire length of the tool sample, but the only place material has been removed is at the notch.

The specimen is symmetric and cracks are also initiated at the three positions similar to the one shown on the picture. Each tool specimen therefore contains 4 cracks.
